**ADVANCED ACS VALVE  
SEALING SURFACE COMPATIBILITY  
INVESTIGATION**

G. R. Pfeifer  
H. Wichmann  
Dr. R. Kratzer

This is the final report on the Advanced ACS Valve Sealing Surface Compatibility Investigation performed by The Marquardt Company, CCI Aerospace Corporation, Van Nuys, California, for the Air Force Rocket Propulsion Laboratory under contract FO-4611-70-C-0052 dated 20 April 1970. This task was conducted under the USAF Project 3058. The objective of the program was to determine the causes leading to leakage of the Marquardt Advanced ACS Valve when operated using chlorine pentafluoride or gaseous fluorine as propellants. Objectives of the program were accomplished with design data developed which can lead to a completely successful seat and poppet closure. The period of performance covered by this report is from 15 May 1970 through 15 July 1971. Edwin L. Lantzer, 1st Lt., USAF was the AFRPL Project Engineer for the program.

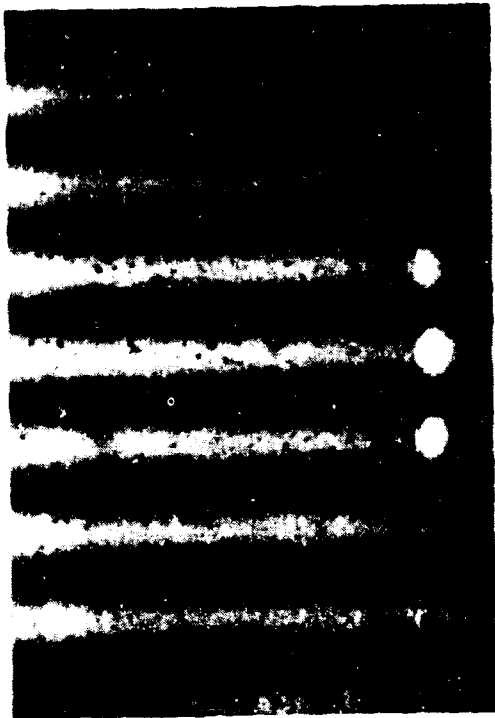
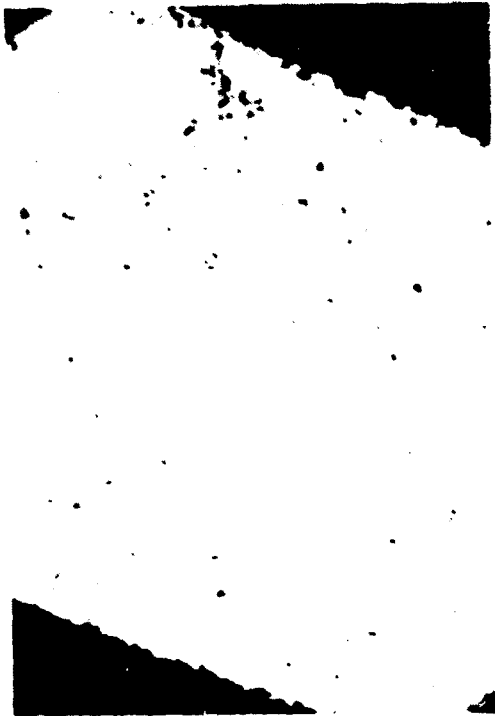
The surface of the tungsten carbide parts was quite satisfactory prior to the test, however, after the test, examination of the parts revealed significant deterioration of not only the sealing surface but also the adjacent statically exposed surfaces. Surface photos and interferograms of the seat surface prior to and after the test are shown in Figure 81. Prior to the test, the surface was smooth with randomly distributed surface holes. After the test in chlorine pentafluoride, the seating surface was degraded in finish with some grooving apparent on the surface of the seat land. As shown in Figure 82, the non-impact areas were quite pitted with considerable loss of material surface. Comparison of profilometer traces made of the seat prior to and after the test on the statically exposed poppet showed that the surface was still quite flat, however, a significant number of holes had been opened up. The seat land surface was too rough to profilometer at 2.5 microinches per profilometer

WC SEAT NO. 18 BEFORE NORMAL IMPACT VALVE  
TEST IN  $\text{CIF}_5$  - 210X INTERFERENCE PHOTO

WC SEAT NO. 18 AFTER NORMAL IMPACT VALVE  
TEST IN  $\text{CIF}_5$  - 210X INTERFERENCE PHOTO

WC SEAT NO. 18 BEFORE NORMAL IMPACT VALVE  
TEST IN  $\text{CIF}_5$  - 210X SURFACE PHOTO

WC SEAT NO. 18 AFTER NORMAL IMPACT VALVE  
TEST IN  $\text{CIF}_5$  - 210X SURFACE PHOTO

paper division so the part was run at lower magnification as shown in Figure 83. The tungsten carbide part was the most severely degraded seat tested. Surface level of the seat was eroded approximately 250 microinches with grooves of 50 to 100 microinches peak to valley height on the seat surface.

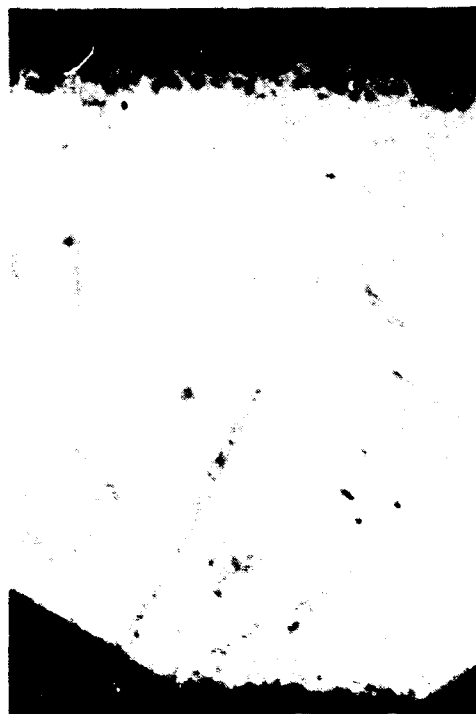
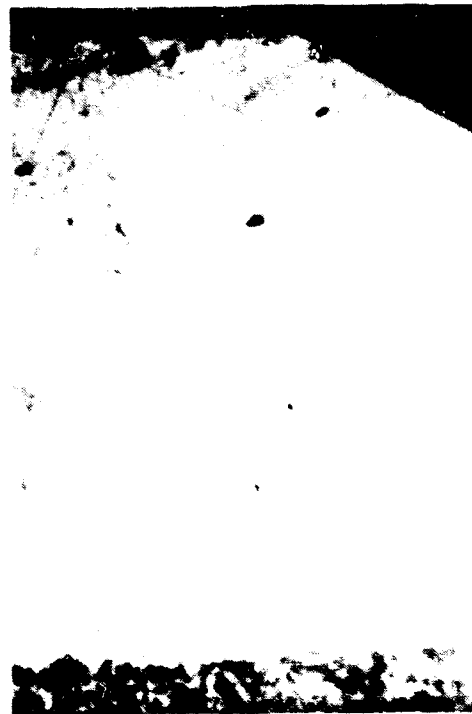
Appearance of the seat which was tested at low impact levels in gaseous fluorine was almost identical to that of the low impact seat tested in chlorine pentafluoride. Figure 92 shows surface photos and interferograms of the seat tested in gaseous fluorine at low impact prior to and after the test. As with the chlorine pentafluoride seat, the only change in the seat surface noticeable is the occurrence of random occasional lumps or surface contamination. No evaluation was made of the poppet from the valve tested at low impact in gaseous fluorine. It was necessary to coat the aluminum oxide parts with a thin carbon film to make them conductive for examination with the scanning electron microscope. Since there was some possibility of requiring parts for further examination which had been maintained in an inert atmosphere to prevent contamination and which had not been coated with carbon, it was decided to skip the electron microscope examination because two other parts were available which had been tested in both propellants. As it turned out, there was insufficient time available in the S. E. M. to examine all parts so the poppet would have been skipped in any case. Comparison of proficorder traces made of the seat land showed similar results to that obtained on the low impact seat tested in chlorine pentafluoride (Figure 93) with no significant differences apparent.

Al<sub>2</sub>O<sub>3</sub> SEAT NO. 12 AFTER LOW IMPACT VALVE  
TEST IN GF<sub>2</sub> - 210X INTERFERENCE PHOTO

Al<sub>2</sub>O<sub>3</sub> SEAT NO. 12 BEFORE LOW IMPACT VALVE  
TEST IN GF<sub>2</sub> - 210X SURFACE PHOTO

Al<sub>2</sub>O<sub>3</sub> SEAT NO. 12 AFTER LOW IMPACT VALVE  
TEST IN GF<sub>2</sub> - 210X SURFACE PHOTO

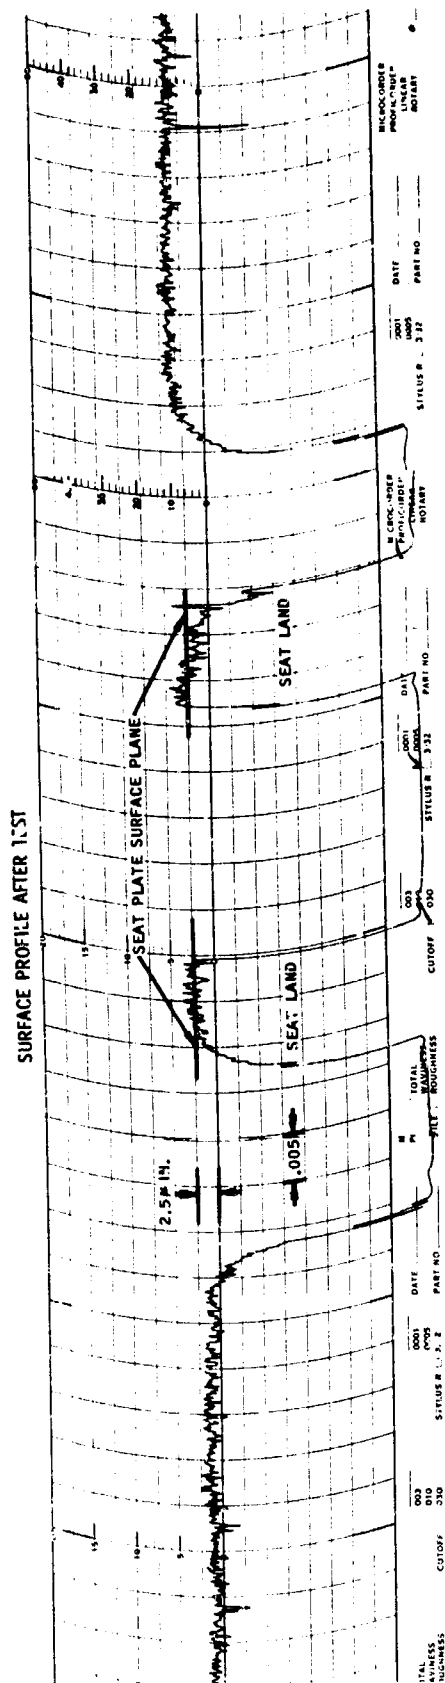
Figure 93

AL2 O3 SEAT  
SURFACE PROFILE AFTER 100,000 CYCLE VALVE TEST - LOW IMPACT - GF2
